River Recovery Plan for the Dale River

Incorporating foreshore and channel assessment

REPORT NO. RRP 10
APRIL 2006

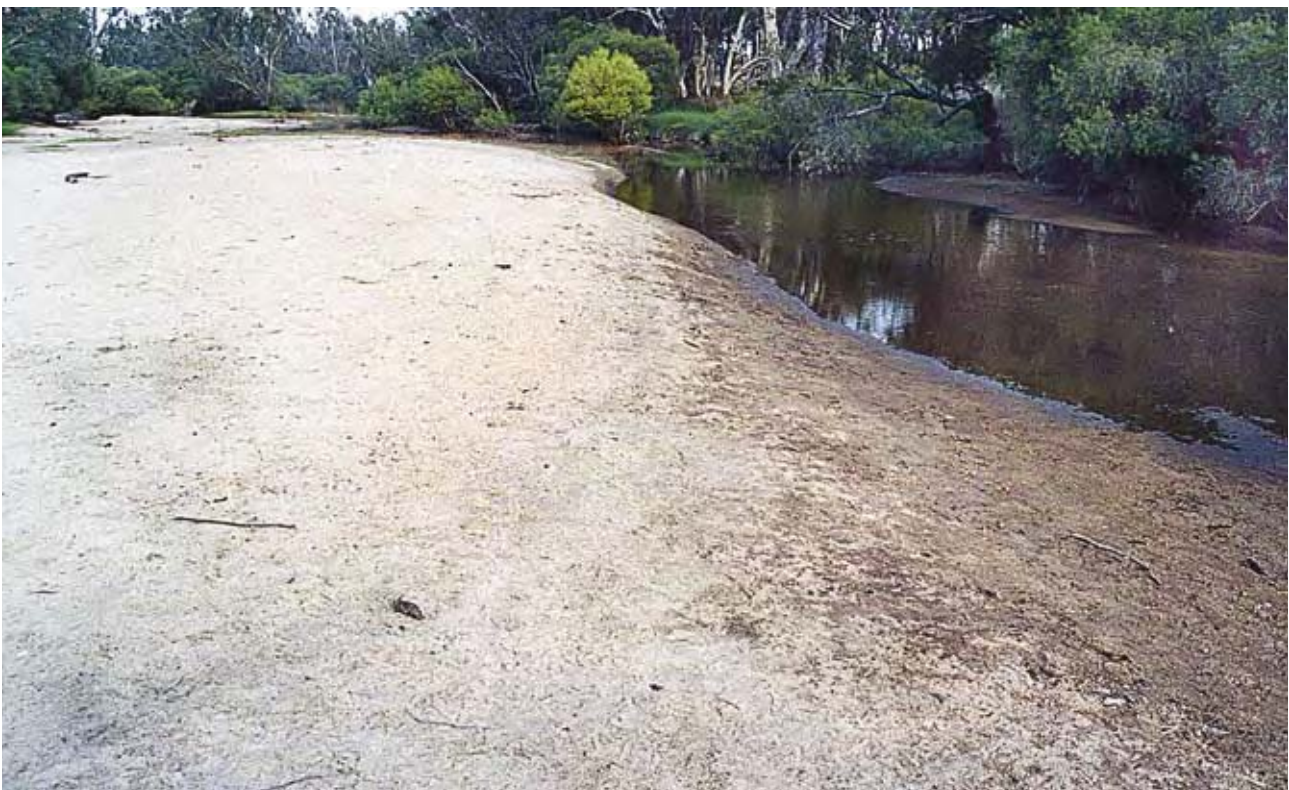
Image 6. Sediment slug smothering Reserve Pool

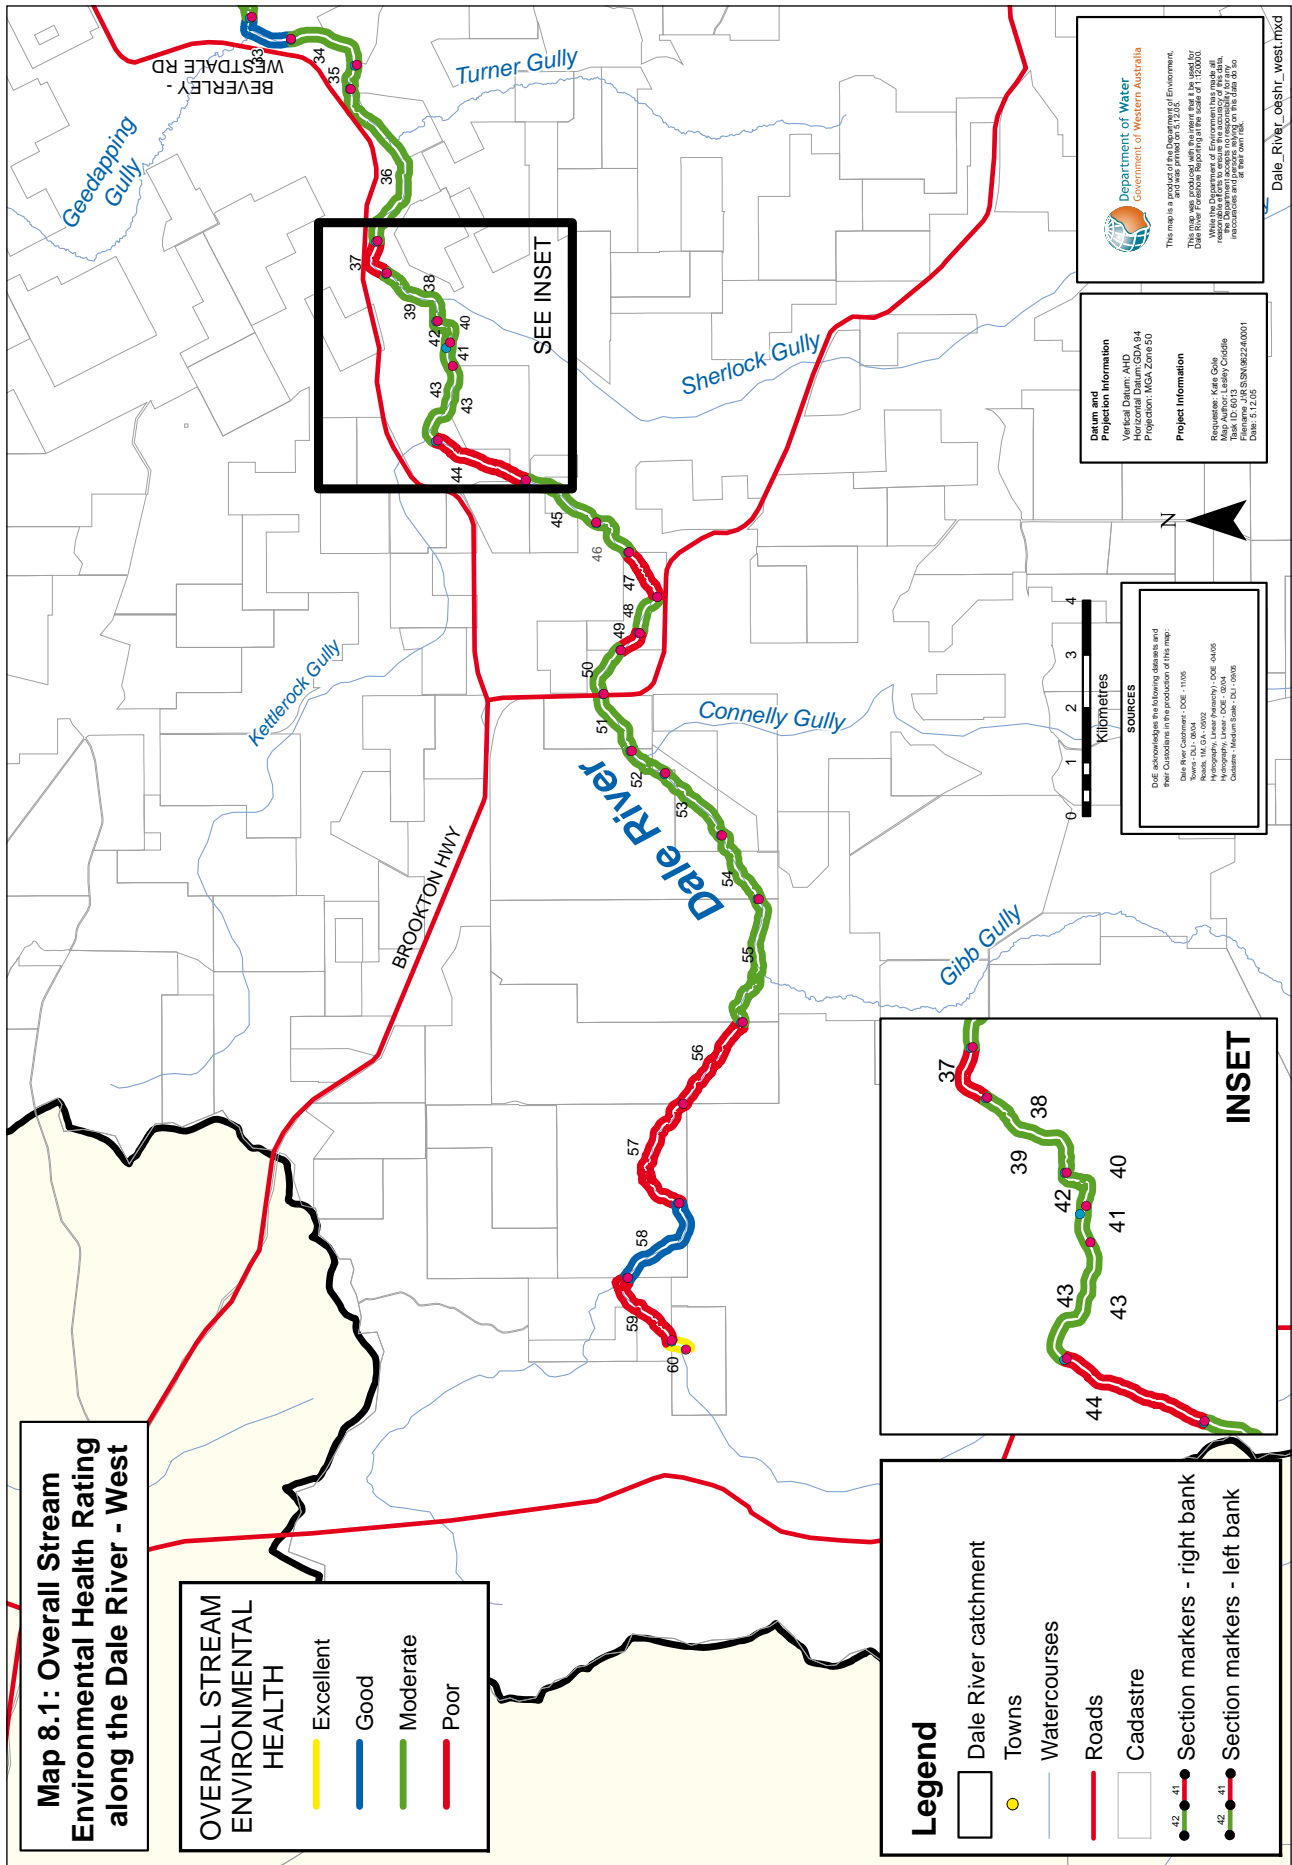
Map 8.1. Overall stream environmental health rating along the Dale River – West

Seventy-seven percent of sections have a moderate overall stream environmental health rating (OESHR) with 18% of sections rating as poor, 3% as good and 2% as excellent (Maps 8.1 and 8.2). Most of the individual categories are scored as moderate (Table 8) however the stream
